TEST REPORT

Report No. : THGD17110212360-2-EN Date: Nov 03, 2017

Sample Name : Filter LK series

Model No. : LK9805

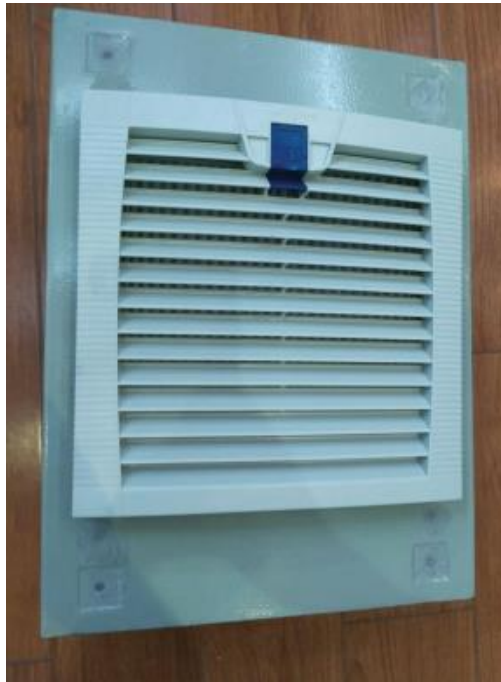
Sample Photo(s)

Material : ABS

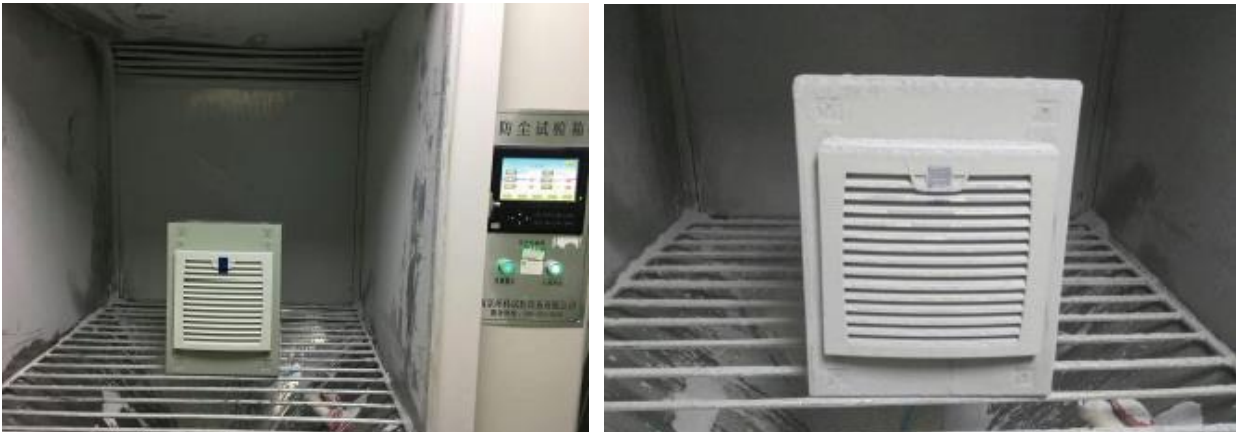
Sample Photo(s) during the test:

1. Test Item: IP5X Dust proof

Test setup: Dust-proof chamber, Model No. : SC-010.

Test Conditions: 1) The amount of talcum powder to be used is 2kg per cubic meter of the test chamber volume.
2) Test period: 8 hours

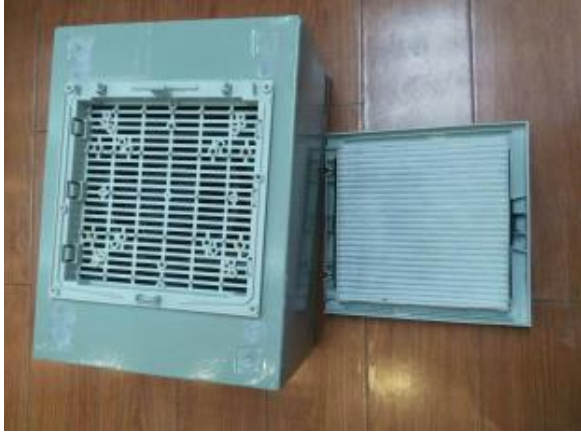
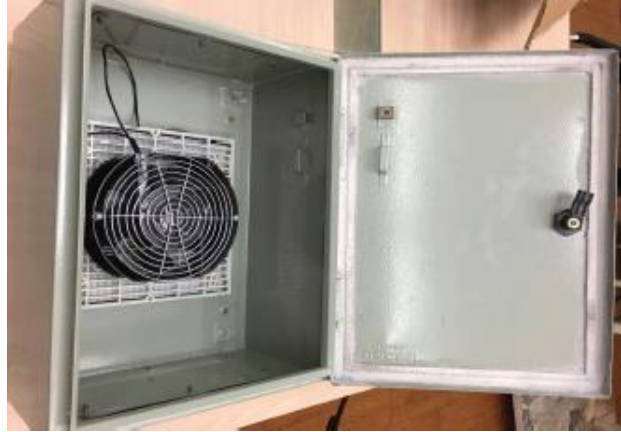
Sample Photo(s) after the test:

Sample Name	Test Results
Filter PFD series	No dust observed inside the test sample

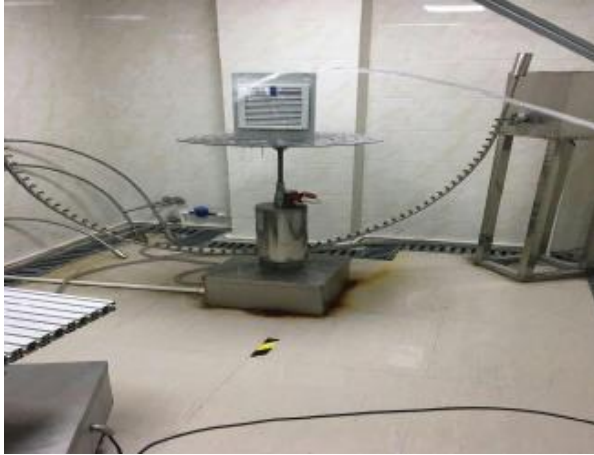
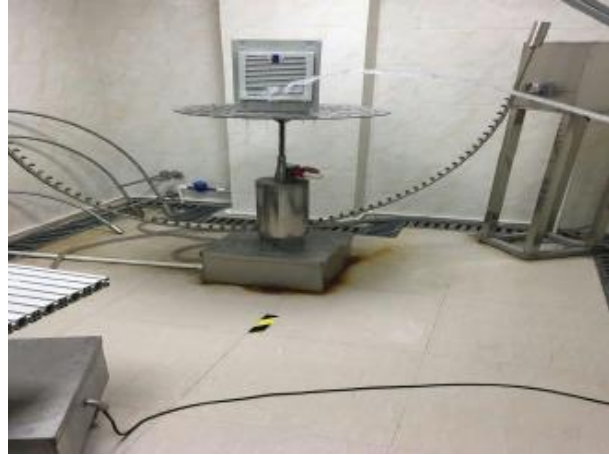
Sample Photo(s) during the test:

2. Test Item: IPX5 Water proof

Test setup: Water proof test chamber, Model No. : IPX1-8

- Test Conditions:**
- 1) Internal diameter of the nozzle: 6.3 mm;
 - 2) Delivery rate: (12.5 ± 0.625) L/min.
 - 3) Test duration per square meter of enclosure surface area likely to be sprayed: 1 min.
 - 4) Minimum test duration: 3 min.
 - 5) Distance from nozzle to enclosure surface: between 2.5 m and 3 m.

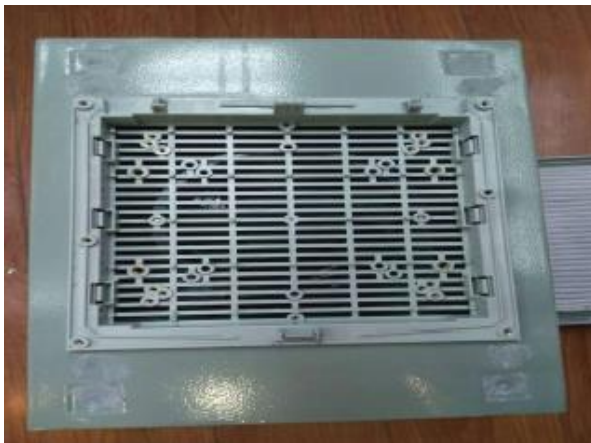
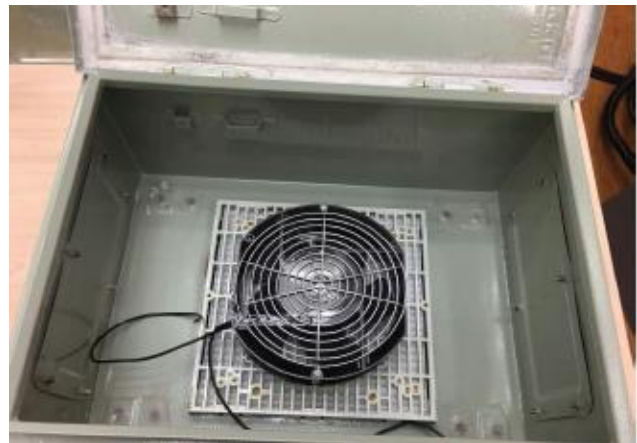
Sample Photo(s) after the test:

Sample Name	Test Results
Filter PFD series	No deposits of water is observable inside the enclosure
