TEST REPORT

Report No. : THSH17122012832-EN

Sample Name : Fan and Filter

Test Requested : IP55

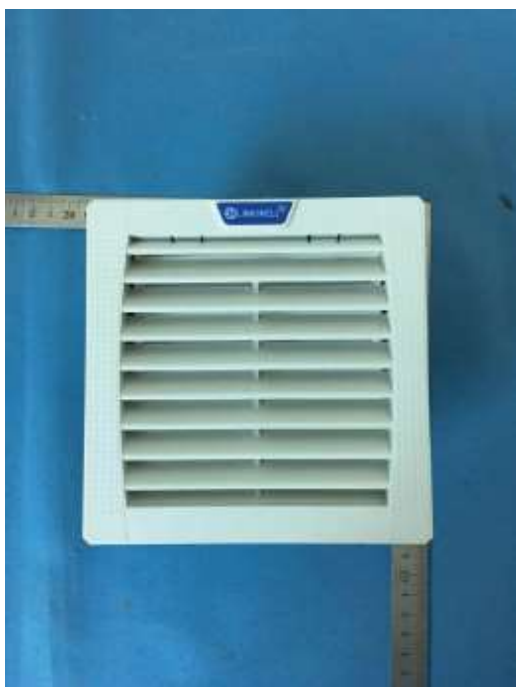
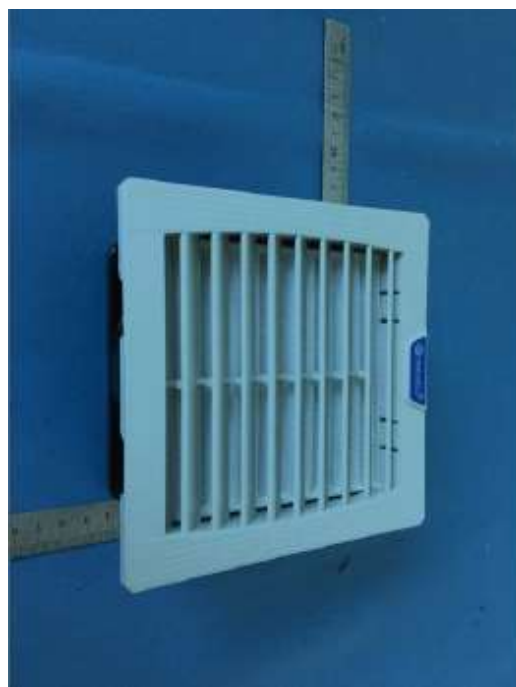
Sample Photo(s)

Model No. : FF series, EF series

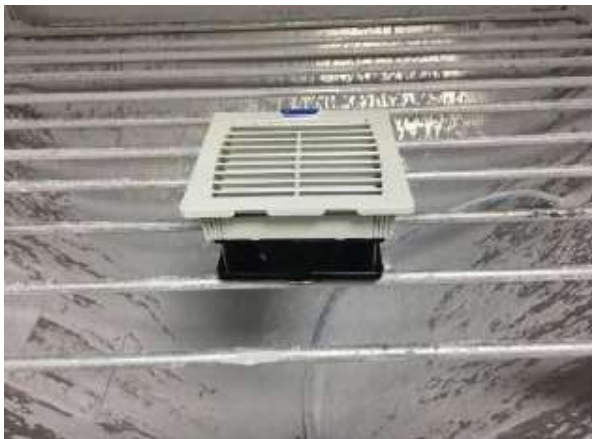
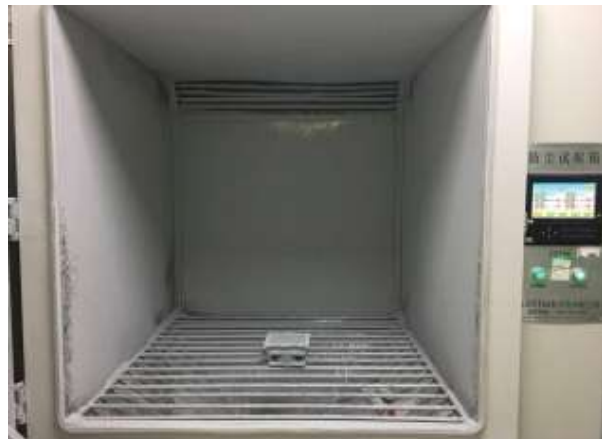
Sample Photo(s) during the test:

Test setup: Dust-proof chamber, Model No. : SC-010.

Test Conditions: 1) The amount of talcum powder to be used is 2kg per cubic meter of the test chamber volume.
2) Test period: 8 hours

Sample Name	Test Results
Fan and Filter	No dust observed inside the test sample

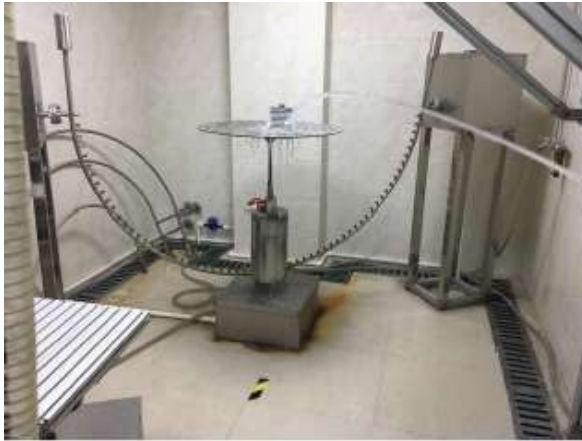
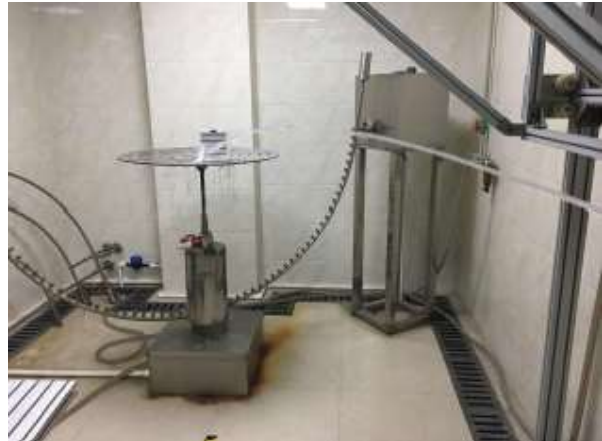
Sample Photo(s) during the test:

Test setup: Water proof test chamber, Model No. : IPX1-8

- 1) Internal diameter of the nozzle: 6.3 mm;
- 2) Delivery rate: (12.5 ± 0.625) L/min.
- 3) Test duration per square meter of enclosure surface area likely to be sprayed: 1 min.
- 4) Minimum test duration: 3 min.
- 5) Distance from nozzle to enclosure surface: between 2.5 m and 3 m.

Sample Name	Test Results
Fan and Filter	No deposits of water is observable inside the enclosure
