## FST Stops a Gnawing Problem

Risers Sealed with Polywater FST to Stop Squirrels from Damaging Cables.

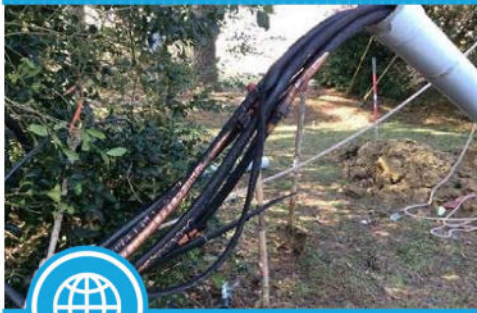
The open top of riser poles and u-guards are vulnerable to both weather and rodents. Customers of an electrical cooperative in North Carolina were becoming frustrated and angry due to service interruptions. When linemen crews were dispatched, they found cables stripped of their protective jackets and insulation. The cause was found to be a squirrel. As the problem persisted, it was obvious the squirrel hadn't been acting alone and the solution was to seal the top of the riser pole to keep the pests out. But sealing larger cables in risers can be difficult due to multiple cables, often in complex configurations such as tri-plexed.

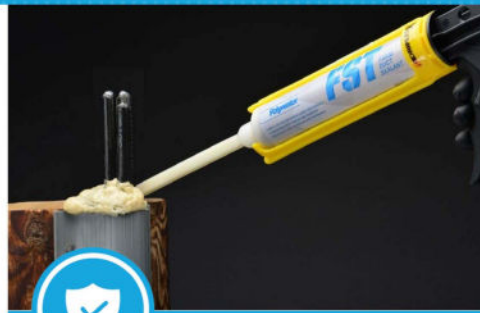
The cooperative evaluated riser sealing products. Mechanical riser covers needed to be specific to the inner diameter of the riser/u-guard, to the number of cables in the configuration, and to the outside diameter of the cables. Additionally, the cooperative feared the plastic seals could be gnawed by rodents. The challenge with traditional duct seal or single-part insulating foam is they fail very quickly.

Polywater FST was selected because it was specifically developed as a conduit sealant to be compatible with all cable jackets and conduit types. The closed-cell foam cures to a strong rigid barrier but is removable when future access is required. It can seal any configuration of cables in any size ID of risers or u-guards.

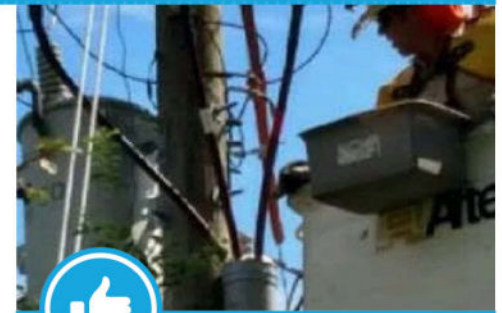
Polywater [FST](#) was installed in the top 3 inches of the riser pole with the cables in place. This airtight/watertight seal created a tough, UV stable barrier to weather and rodents. Polywater FST is compatible with all cable/conduit sizes and materials so the system remained intact. The cooperative was very pleased with the results and the customers were much happier with the reduced outages.

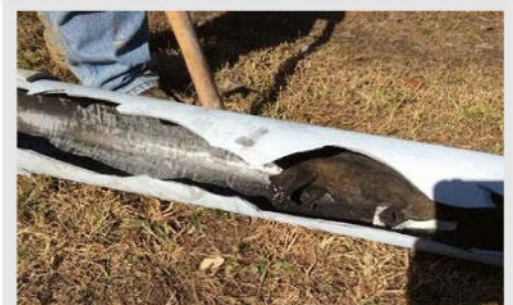
A closer look at the cause of damaged cables and outage.
